2008 Nautical Archaeological
Assessment of Steamer Wrecks
Swan (21AK84) and *Andy Gibson*
(21AK0109) in Aitkin, Minnesota

2008 Archaeological Assessment of Steamer Wrecks *Swan* (21AK84) and *Andy Gibson* (21AK0109) in Aitkin, Minnesota

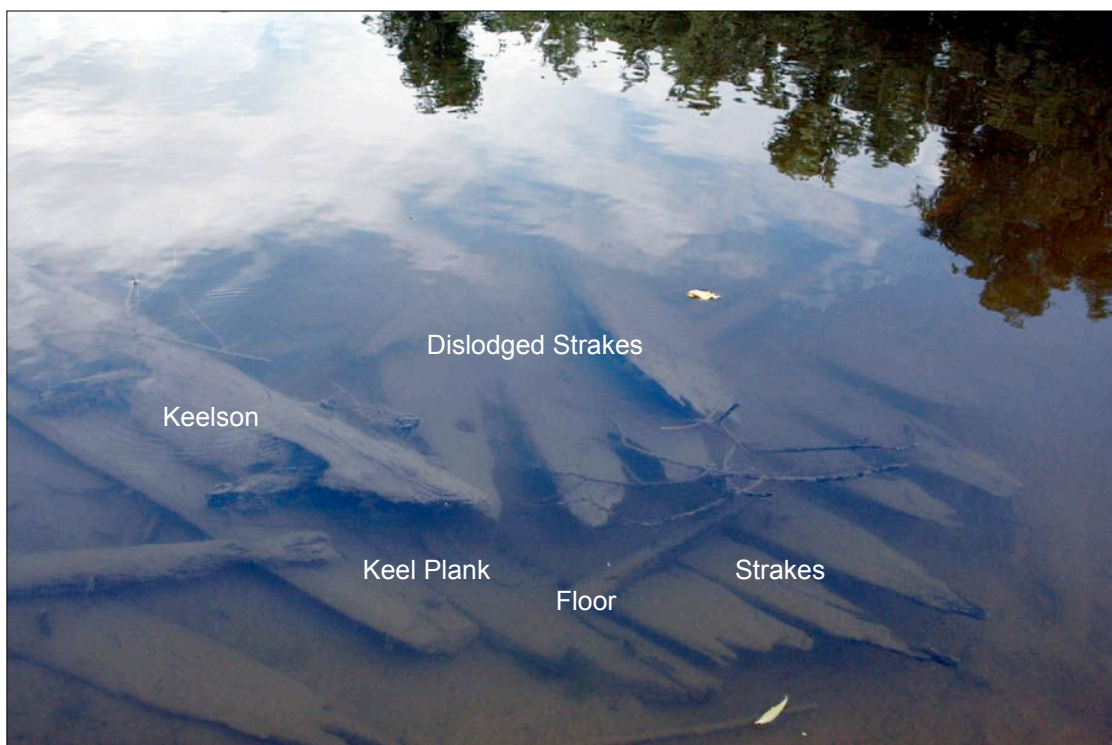
Above: Port bow with strakes, keelson, floors, and the keel plank. By Kelly Nehowig.

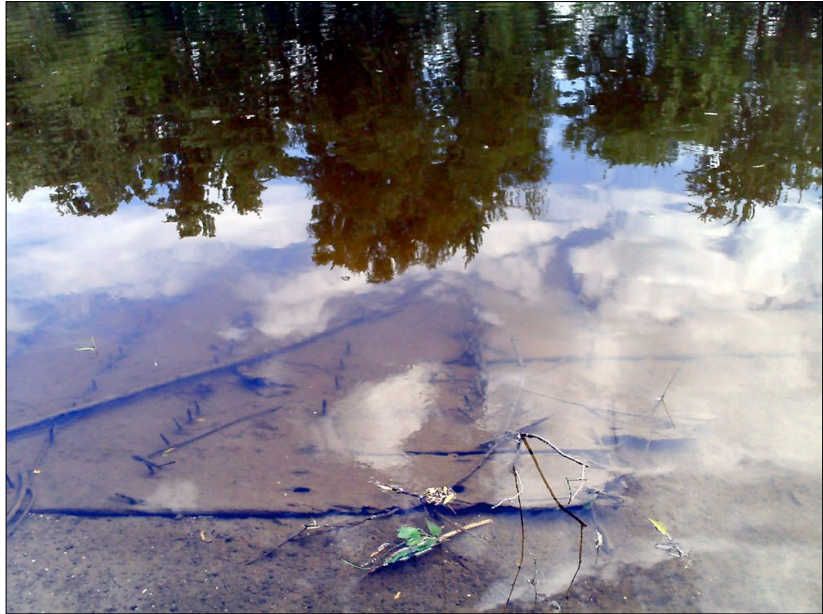
Top Right: Strakes and fasteners depicting the floor pattern; these construction attributes may be newly exposed since 1996.

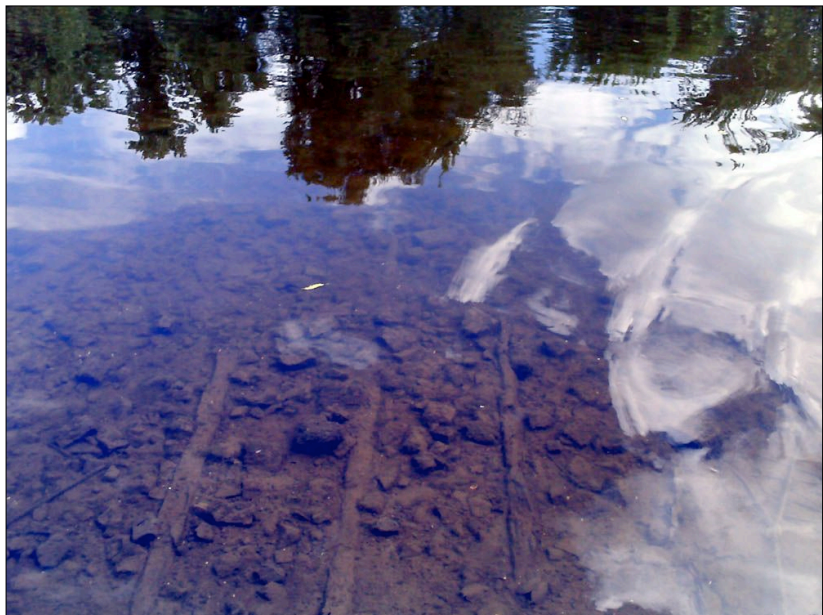
Bottom Right: A series of four floors with sediment filling the spaces between them; these may be newly exposed since 1996.

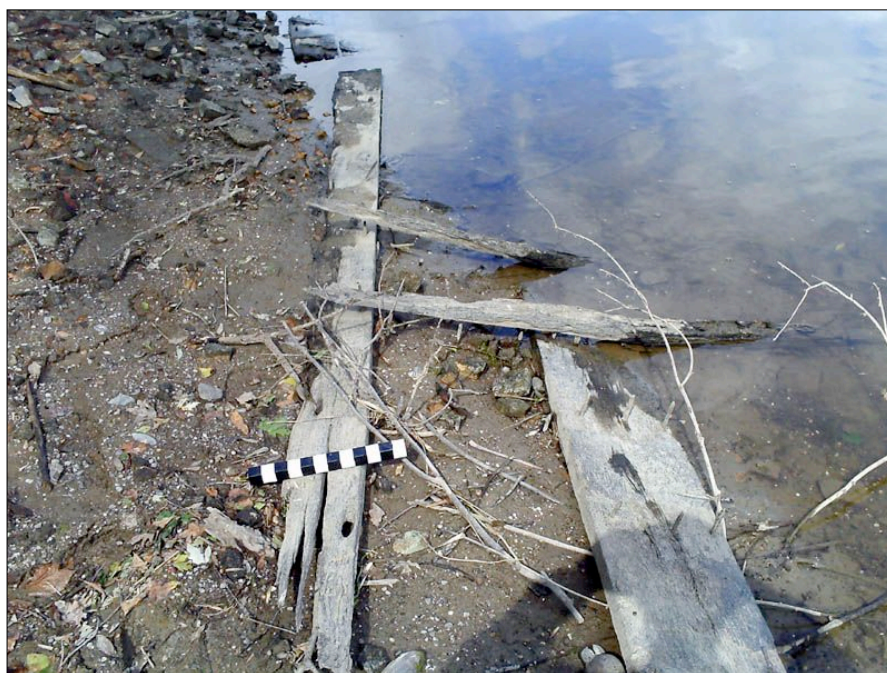
Starboard strakes and floors exposed since 1996.

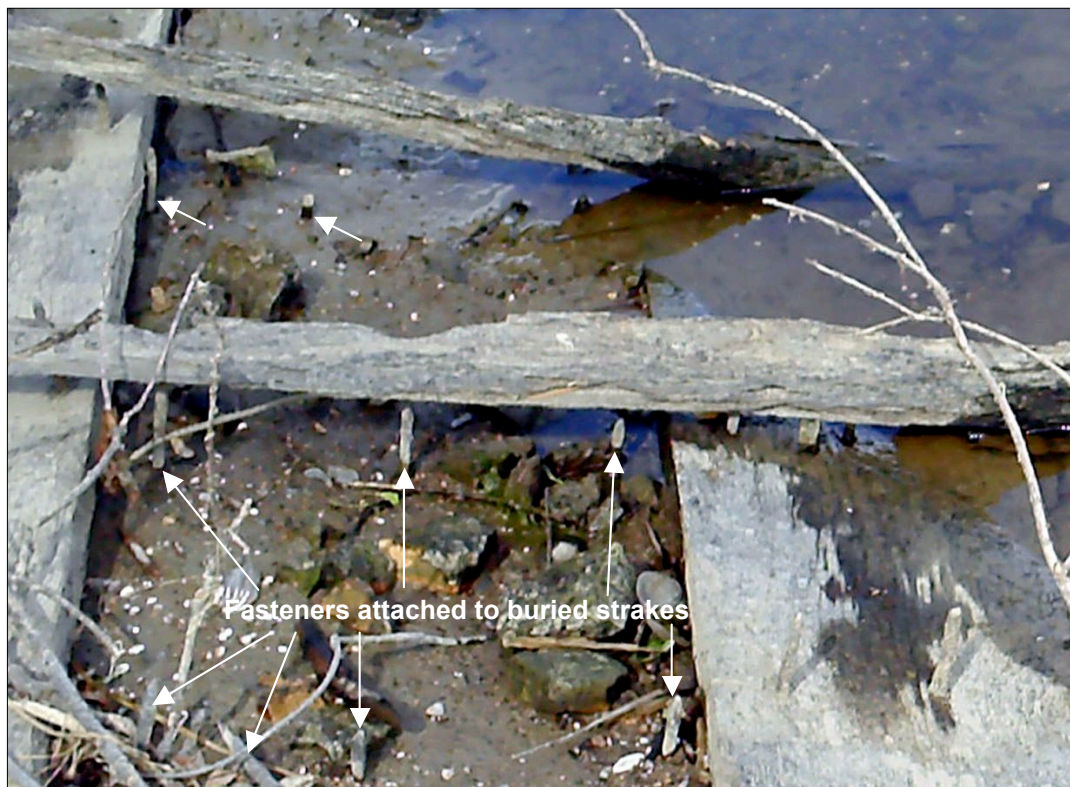
Starboard strakes and floors on an exposed sandbar with iron fasteners protruding through sediment attached to buried strakes. By MHM.

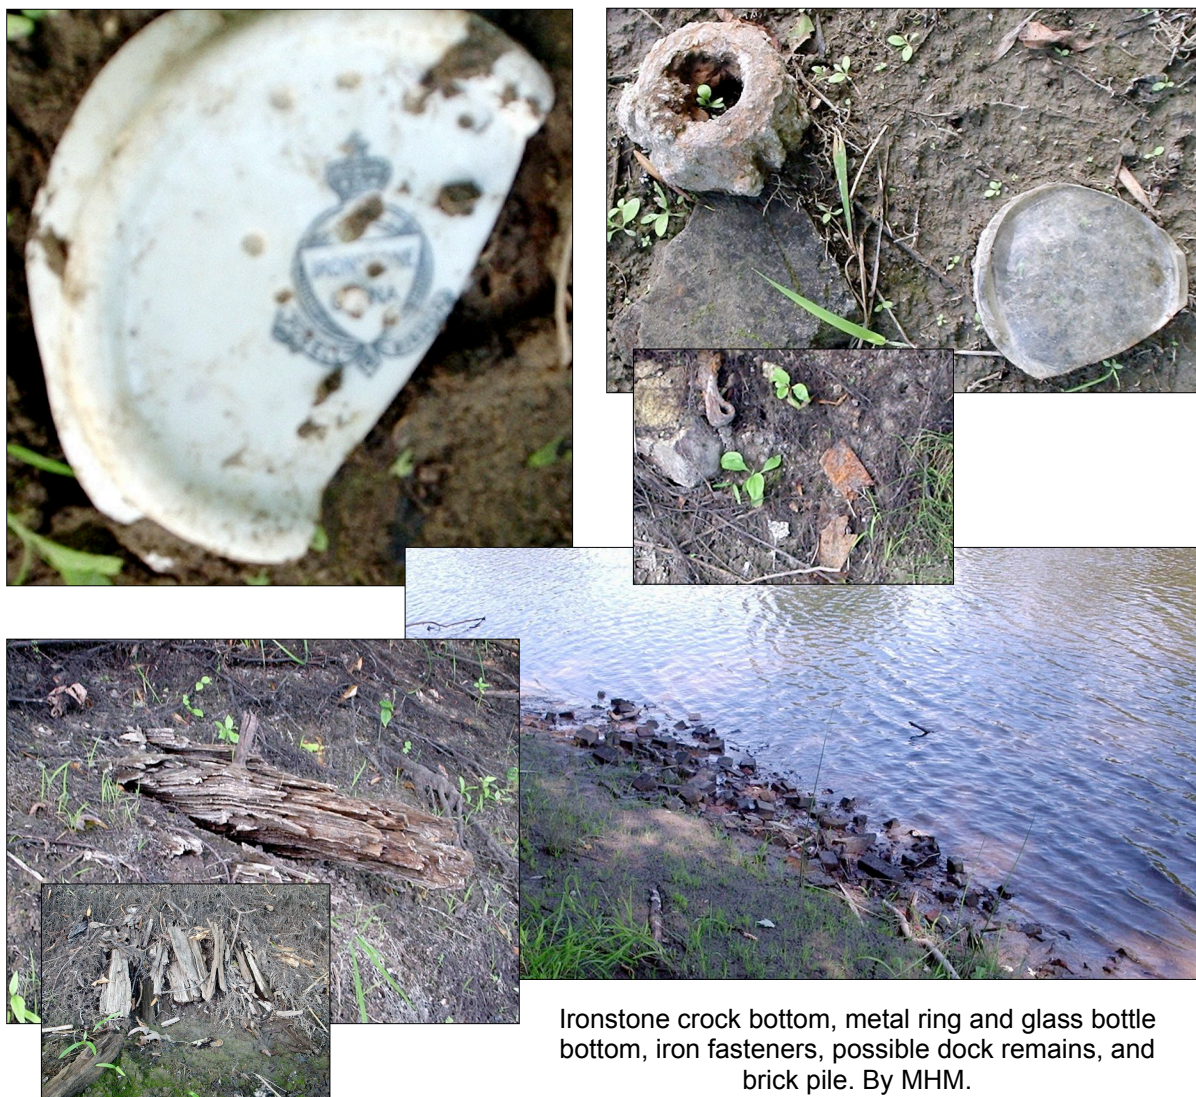
MHM conducted a brief visual survey of the riverbank downstream of *Swan*, west of the mouth of the Ripple River, in areas that under normal river levels would be submerged. Various ceramic, glass, and metal artifact scatters are evident and a substantial, concentrated pile of bricks is set into a sandbar. The possible remains of

a wooden dock or docks protrude from the riverbank as do a series of metal cables and a large beam extends deeply into the sediment. Two pilings that may be

supports for a dock stick up from the river bottom, and two worked wooden planks imbedded in a sandbar along with a perpendicular beam and metal pipes suggests the may be a buried wreck or a dock.

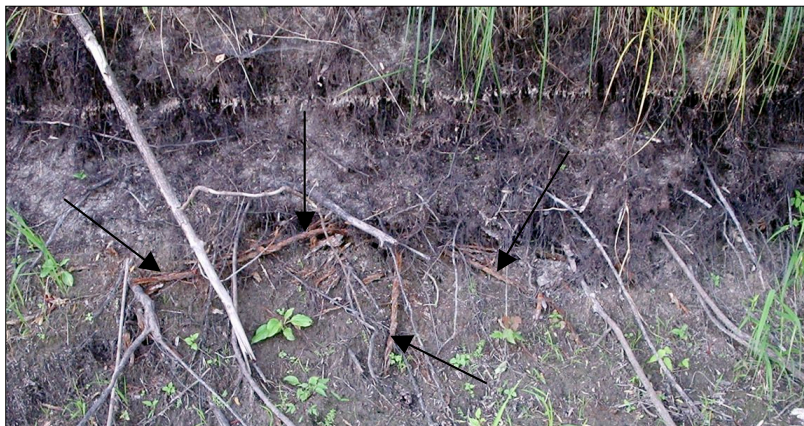
Above: Iron cables in the riverbank during low water conditions.

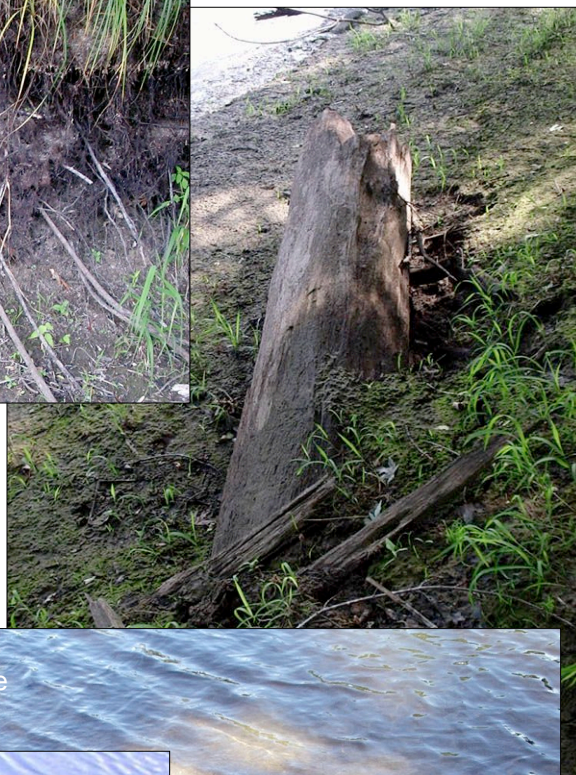
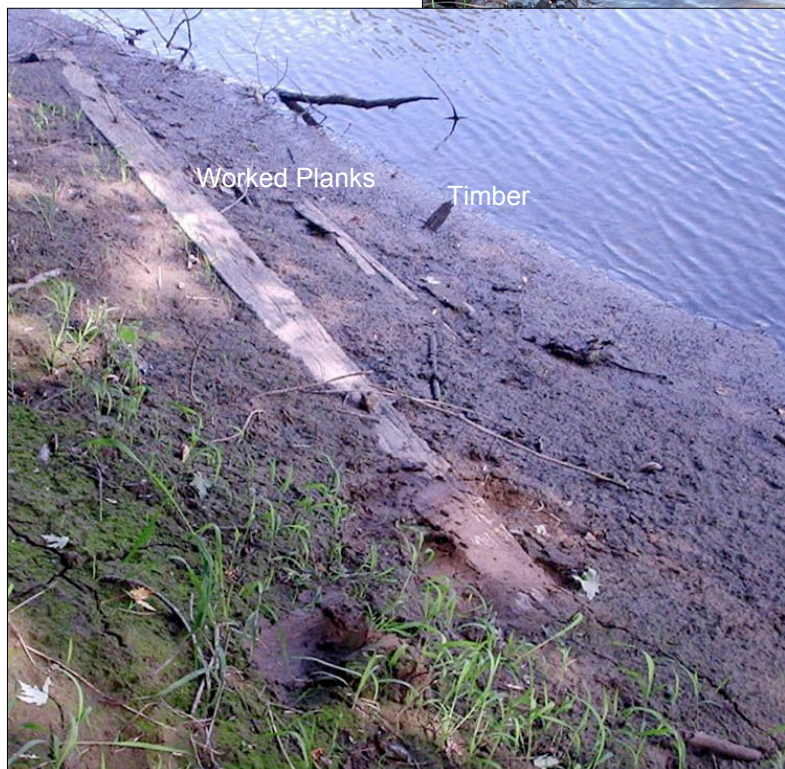
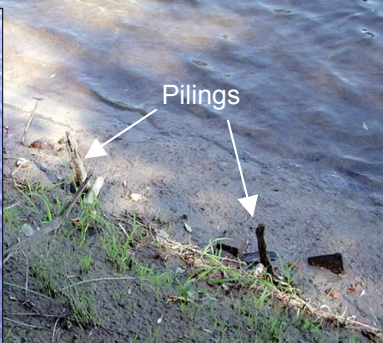
Above: Two pilings next to a brick pile that may have been part of a steamboat mooring or dock.

Left: Two worked planks imbedded in a sandbar at low water, with a possible timber protruding from the mud.

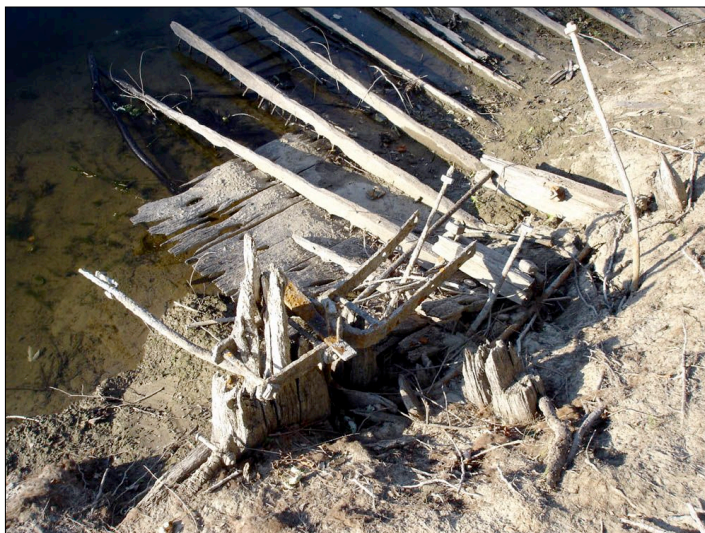
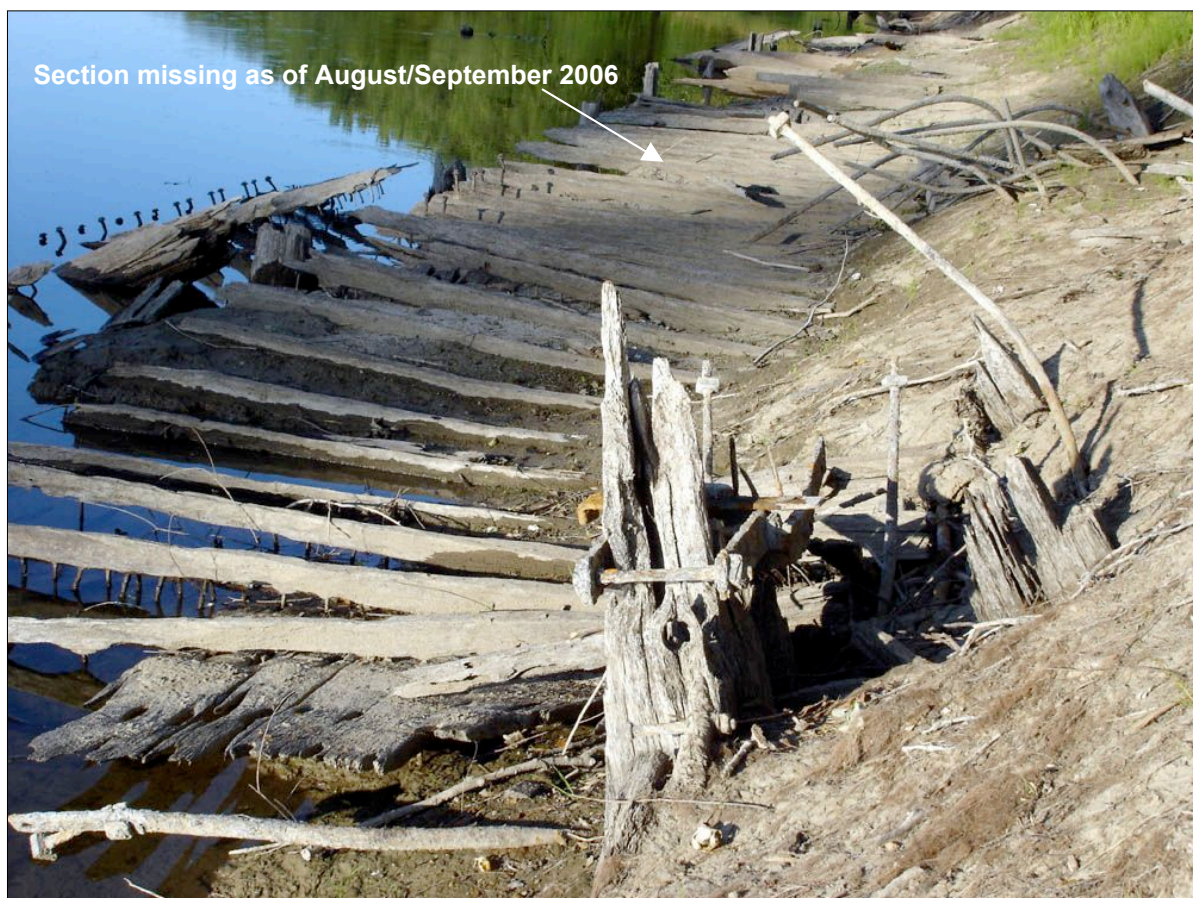
Right: The starboard rudder and metal attachments *in situ*.

Below: View from beyond the stern with the starboard rudder *in situ* and forward portion of the hull still intact.

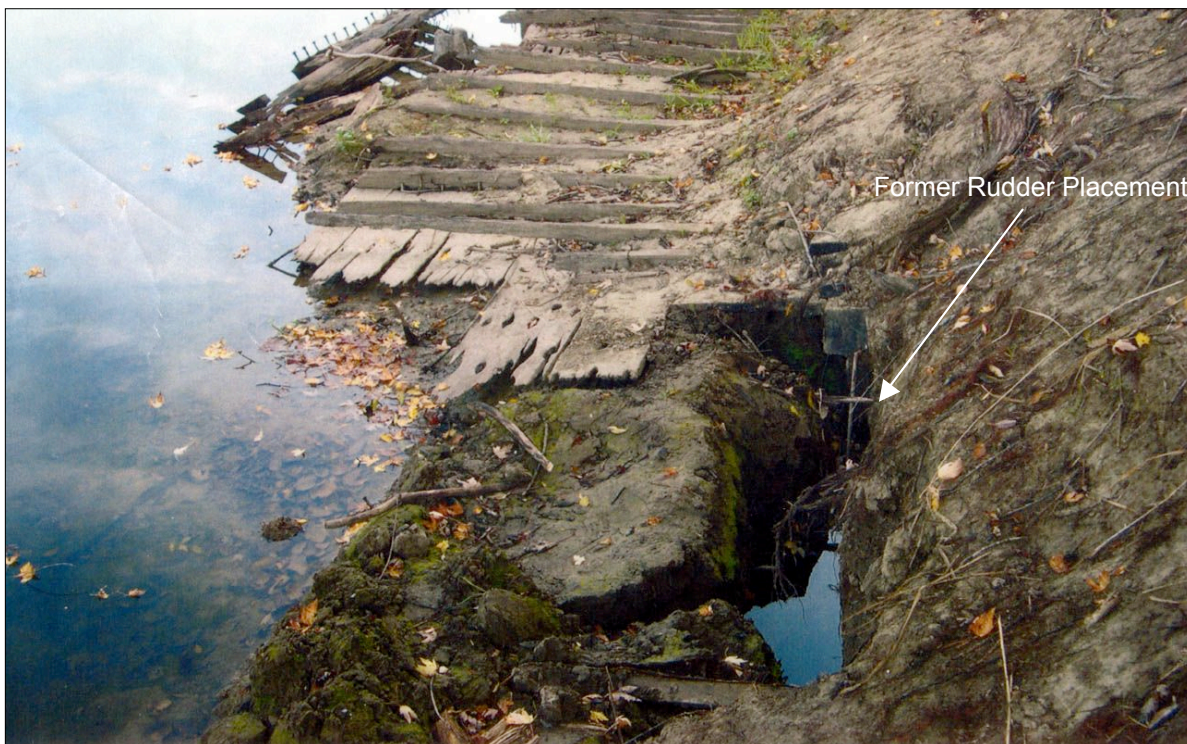
Above: Stern view after the unauthorized removal of the starboard rudder and its attachments.

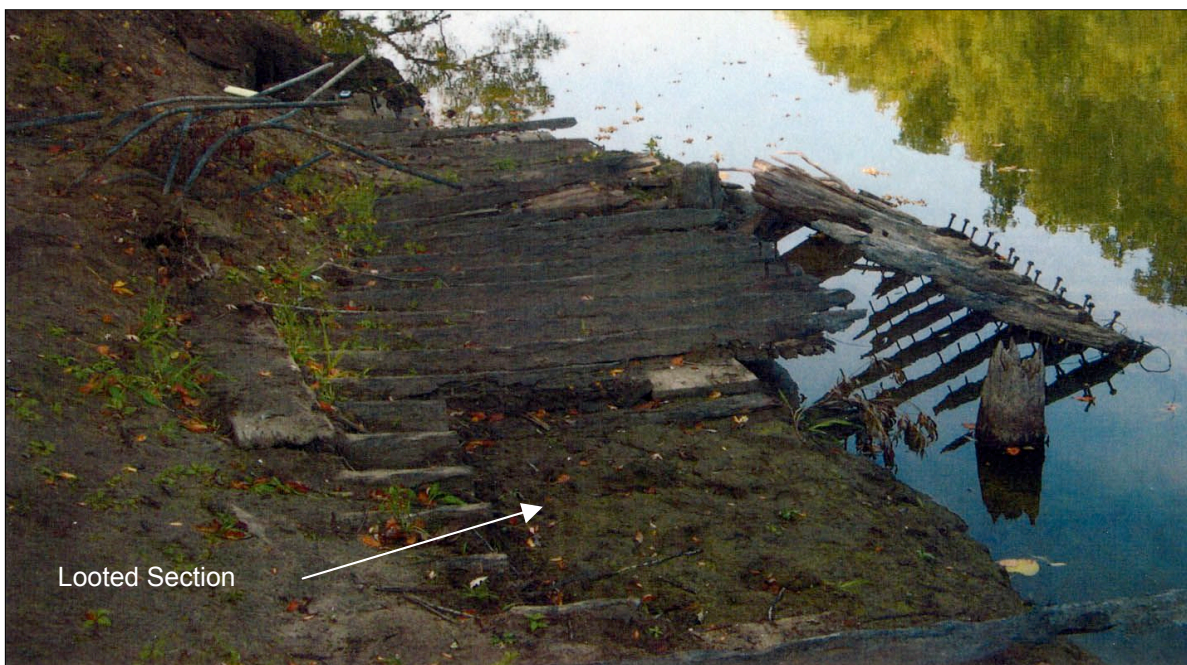
Below: View toward the stern indicating five floors and numerous strakes have been removed with a chainsaw; note the sharp edges to the floors.

As previously mentioned, in addition to the stern damage caused by the removal of the starboard rudder in 2006, it is also evident that a significant amount of intentional damage was inflicted on the wreck amidships by a souvenir hunter. Five

floors extending out from the riverbank have been cut and now have straight ends. Additionally, an undetermined number of floors are missing forward of the cut examples. It is unknown if these floors were looted from the wreck or if they fell victim to ice and water action. This area is now unstable because of the looting of the aft section and the area where the hull was removed is quickly eroding. Regardless, MHM suspects remnants of these timbers might exist under the riverbank on the starboard side, possibly including first futtocks and a hard chine. One amidships section has migrated from the main wreck and slipped into the river that resembles the looted area of the hull. This hull piece is intact approximately five feet further down the river's slope and consists of several strakes and floors.

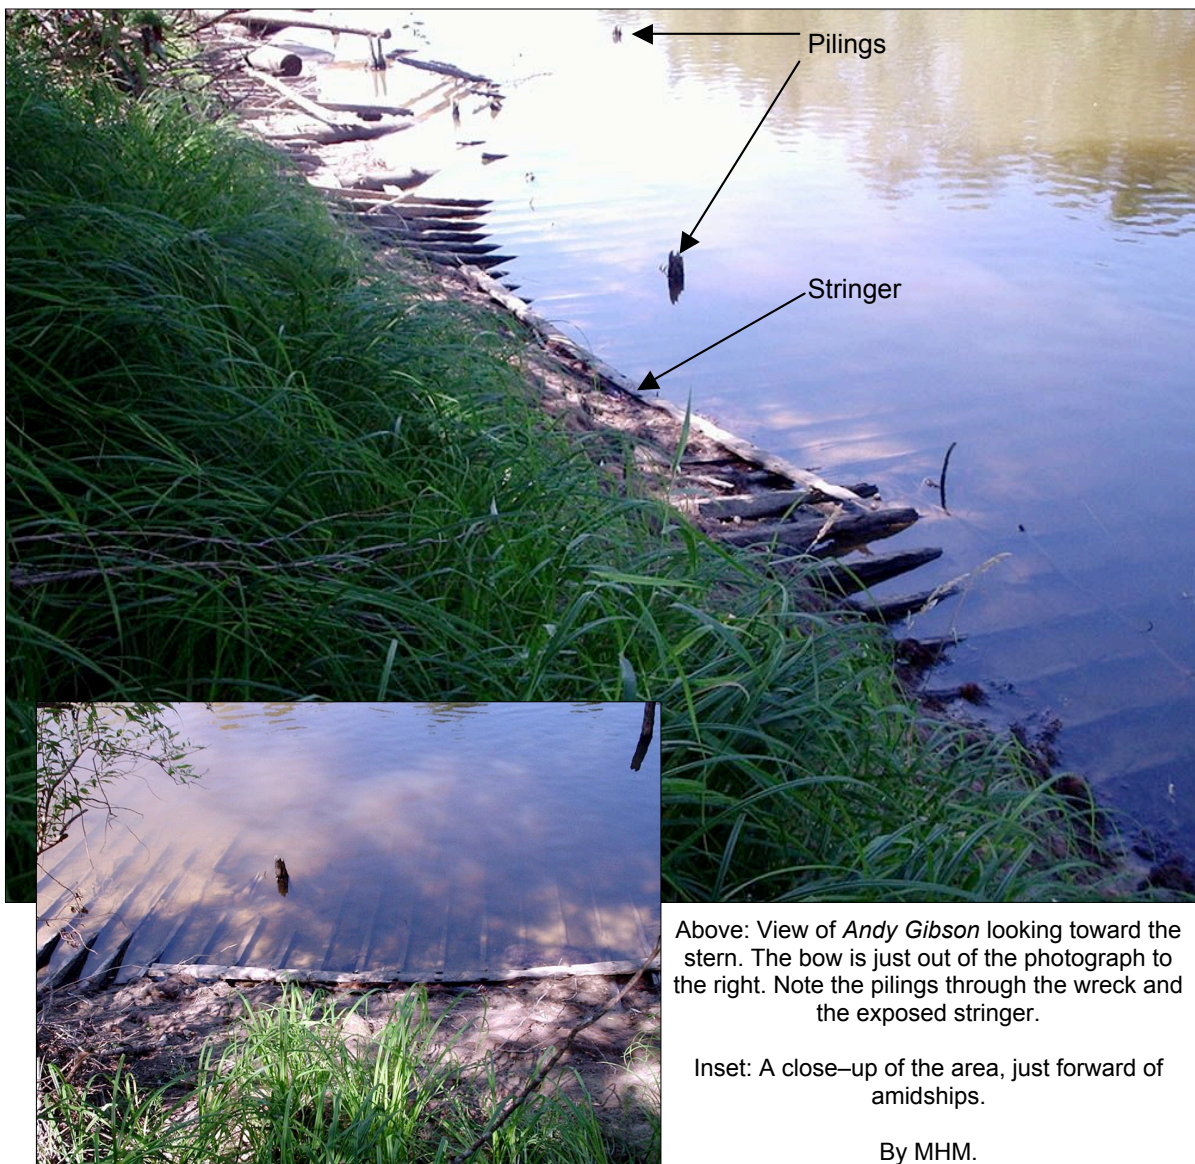
Above: The amidships section of the *Andy Gibson* with the pilings and timbers of the under hull platform evident, and a large section of hull that has slipped further into the river. By Kelly Nehowig.

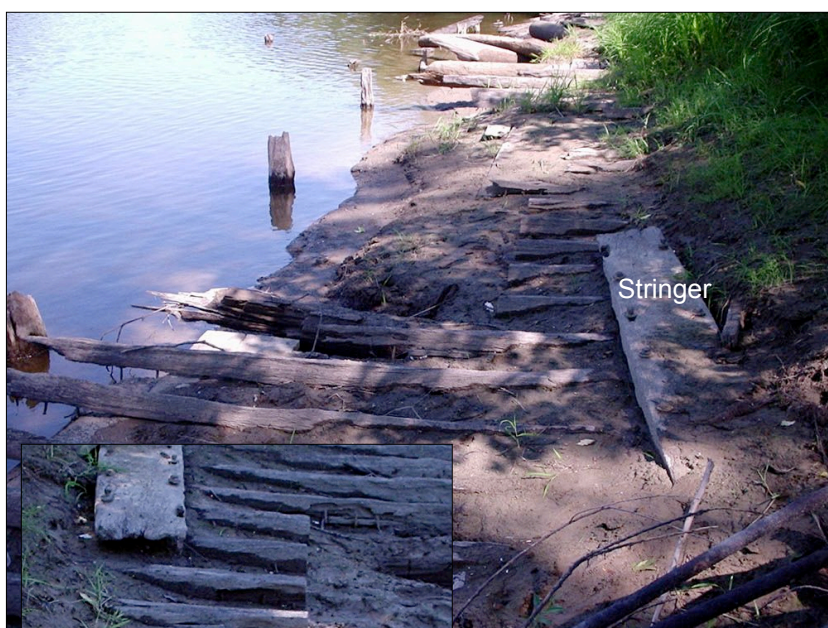
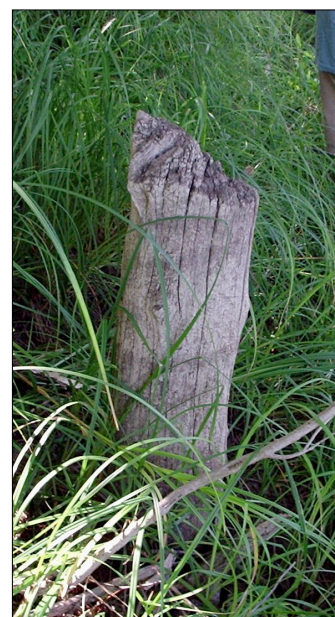
Top: Stern section in August 2008 with floors in varying states of preservation, with platform pilings and timbers evident, and a large stringer with substantial fasteners. By Kelly Nehowig.

Above Right and Inset: Looted and destabilized areas in August 2008. By MHM.

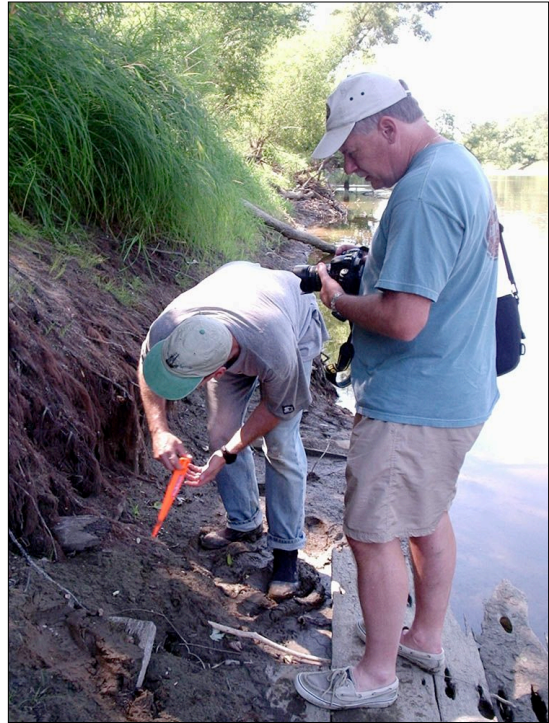
measured 21" long, 8.5" wide, and 1.5" thick. At the stern, Olson and Nehowig cleared a small portion of the soil where the starboard rudder had been removed in an attempt to clarify the amount of the wreck that may lie underneath the riverbank. They discovered a large structure *in situ* that may be the starboard cylinder timber for the now-missing sternwheel. Finally, various iron fasteners are visible throughout the wreck site, imbedded in floors, strakes, stringers, and blocks. Large engine mountings are protruding from the riverbank; near these mountings some deck timbers may survive as well.

Above: Olson and Nehowig at the stern. By MHM.

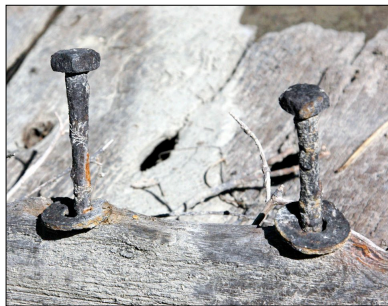
Left: Two large bolts with washers protruding from a floor. By Kelly Nehowig.

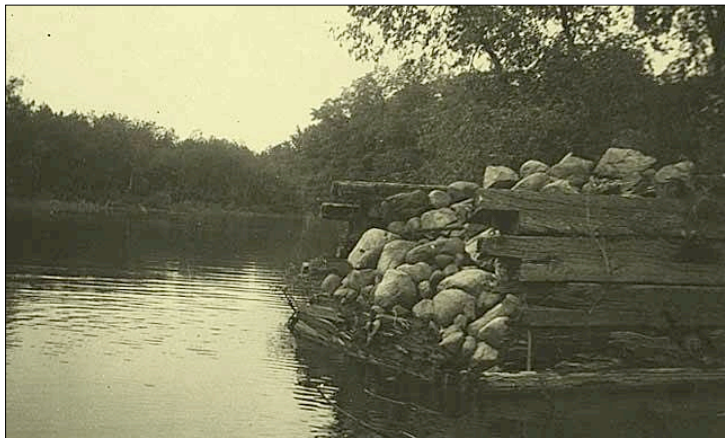
A stone and crib steamer landing near the mouth of the Sandy River. Photograph by Evan A. Hart, July 1949. From Hart 1952, 18.

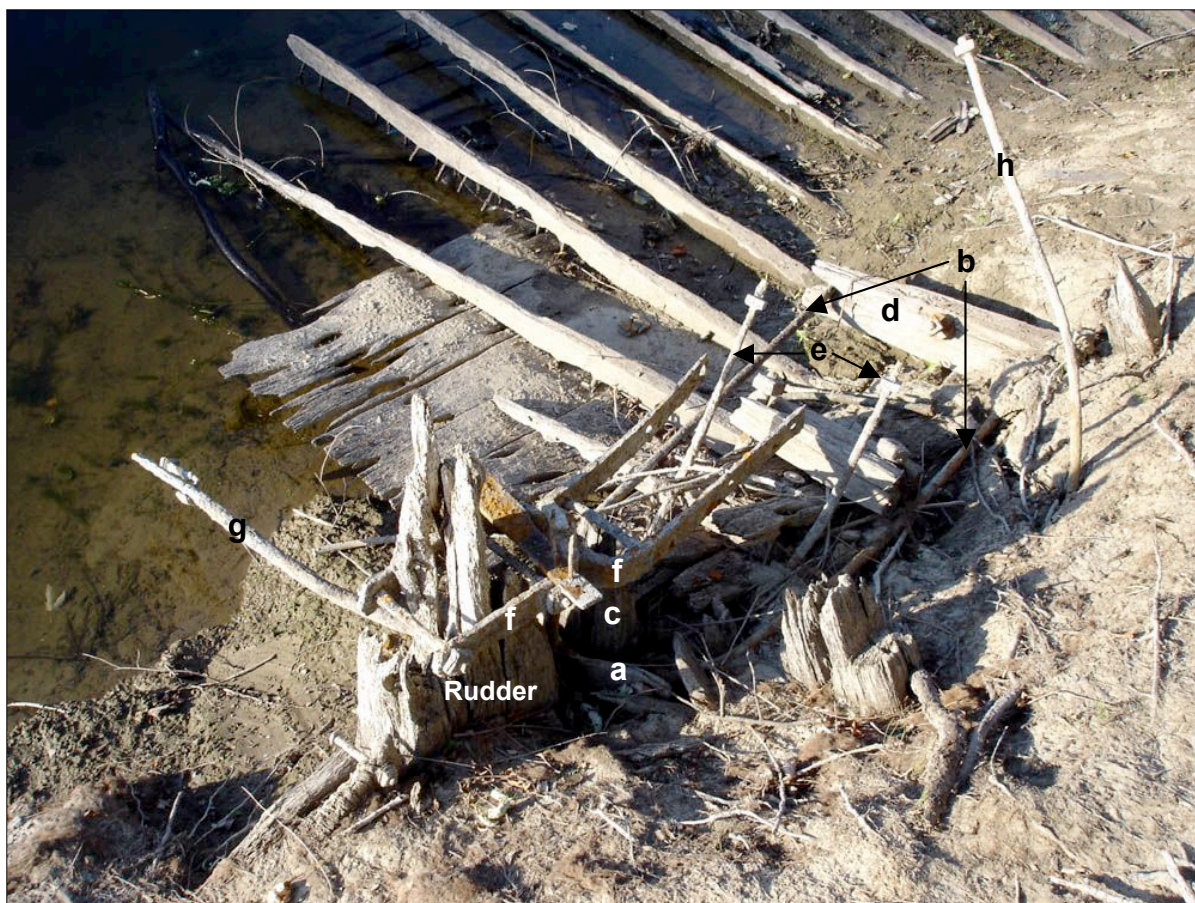
- a – metal plate
- b – 2 rods attached to (a)
- c – starboard sternpost
- d – athwartships beam or block
- e – 2 rods
- f – gudgeons
- g – rudder articulating arm
- h – cylinder timber attachment

A metal plate (a) with two holes on either end supported two rods (b), approximately four feet long. From the available evidence, the plate was attached to the starboard sternpost (c), the top of which seemingly hasn't survived after removal, just forward of the rudder; there may be a skeg underneath the hull, but this cannot be determined at this point. The rods extended forward on either side of the sternpost and their ends were attached with bolts through holes in an athwartships beam or block (d). The purpose of the plate and rods seems to be as a stable attachment point for the sternpost. Another set of rods stuck out of the sediment with bolts near their ends (e). These rods were attached at an approximately 45-degree angle to a piece of the sternpost or skeg.

The rudder is a balanced type whereby 1/3 of its area lies forward of the pivot point. It was attached to the sternpost by four gudgeons (f) and a pintle (i) that was inserted through eyes on the gudgeons. The top three gudgeons are intact, while the lowest is broken, the remains of which are found on a piece of sternpost that was sawed off the wreck. Another metal rod, the rudder articulating arm (g), is now independent of the rudder system but *in situ*, its end was buried in sediment. Originally, one end would have gone through the starboard rudder aft of its pivot point and extended to the master (center) rudder and then to the port slave rudder. This rod allowed the rudders to move in consort. One more substantial component, a large wooden timber (j) with a rod (h) protruding through it, was removed from the wreck. MHM asserts that this piece is a portion of the starboard cylinder timber with one of its accompanying attachments.

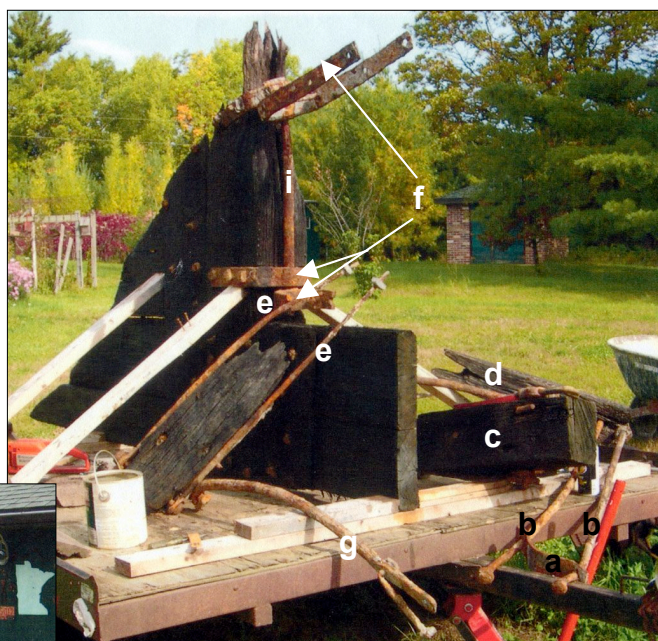
Note: The disarticulated pieces of the rudder, steering mechanism, and some stern area floors are sitting on a trailer in no order with other objects, including a pipe wrench, red pipe, paint can, spray can, and a chainsaw.
